## Redesigned Valve Cage & Cover Eliminate Multiple Gas Leaks

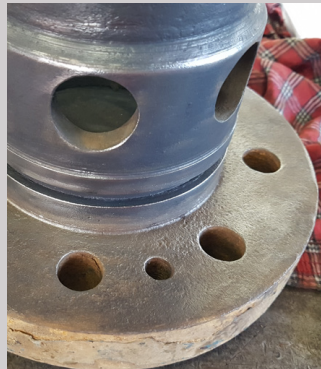
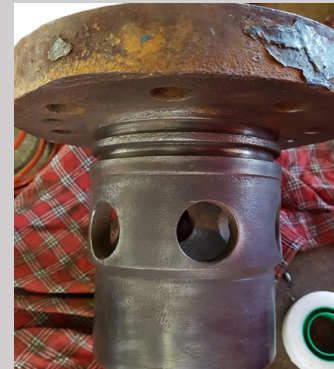
The elements were leaking due to the walls of the valve ports. The components showed a lot of corrosion and superficial pitting. A new valve cover / cage design was required. The addition of new O-rings and gaskets that would improve the seal against the valve port walls and surface of the actuator groove.

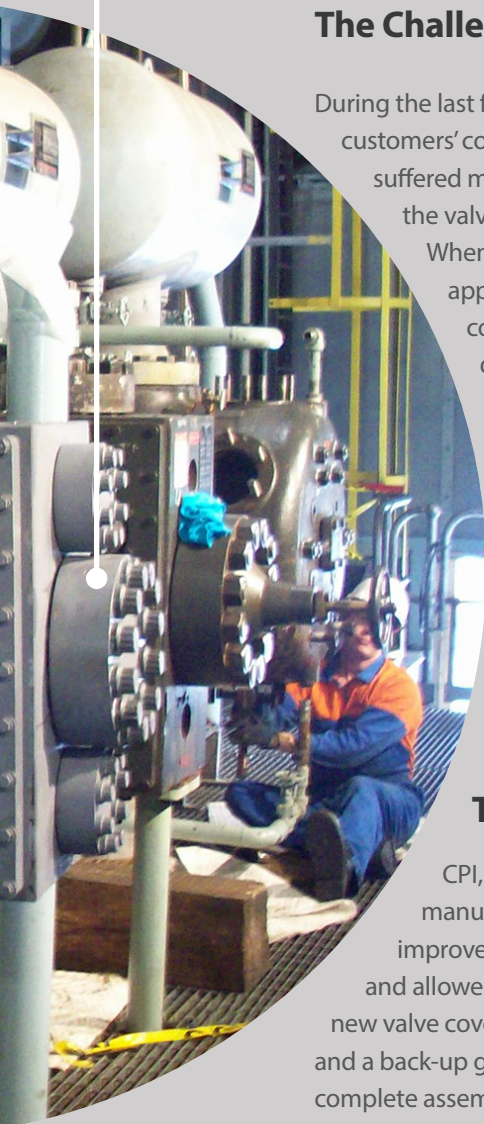
CPI, part of the Howden Group, designed and manufactured a new valve cage and valve cover that improved both gas sealing and maintenance operations and allowed the installation of new pneumatic actuators. The new valve cover includes machined grooves to house O-Rings and a back-up gasket, improving the gas sealing capability of the complete assembly once installed.
